MOVIMENTS DE PLEC
FURROWING MOVEMENTS

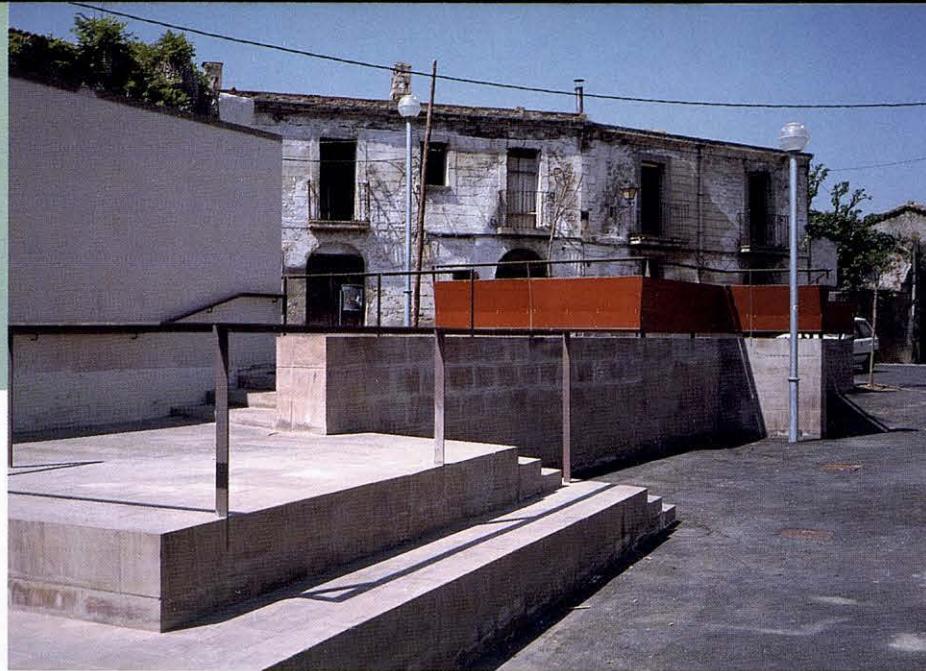
1. Estat original.
Site plan before intervention.
2. Planta de la proposta.
Proposal plan.
3. Alçats.
Elevations.

1. Sobre el carrer Torres i Bages i el jardí lateral: convertir el carrer i el jardí en una unitat "mixta" cotxes-vianants per tal que desaparegui la idea de carrer esquivant el castell, per evitar la sensació que el carrer gairebé s'hi estavella. Amb aquest objectiu s'asfalta el carrer d'un costat a l'altre. Emprant el pendent, es fan emergir superfícies horizontals limitades per murs de pedra com la del castell. Petits illots d'herba que emergeixen del pla negre de l'asfalt. La irregularitat d'aquests illots és el resultat d'incloure sempre en un perímetre dos arbres de l'actual jardí.

1. At Carrer Torras i Bages and the adjacent garden: to combine the street and the garden into a "mixed" vehicle-pedestrian unit to avoid the sensation that the street only just misses crashing into the castle. To achieve this, the street has been asphalted from one side to the other. Making use of the slope, horizontal surfaces emerge limited by walls in the same stone as that of the castle. Small grass islets emerge from the black surface of the asphalt. The irregularity of these islets is the result of keeping within the perimeter the two original trees from the garden.

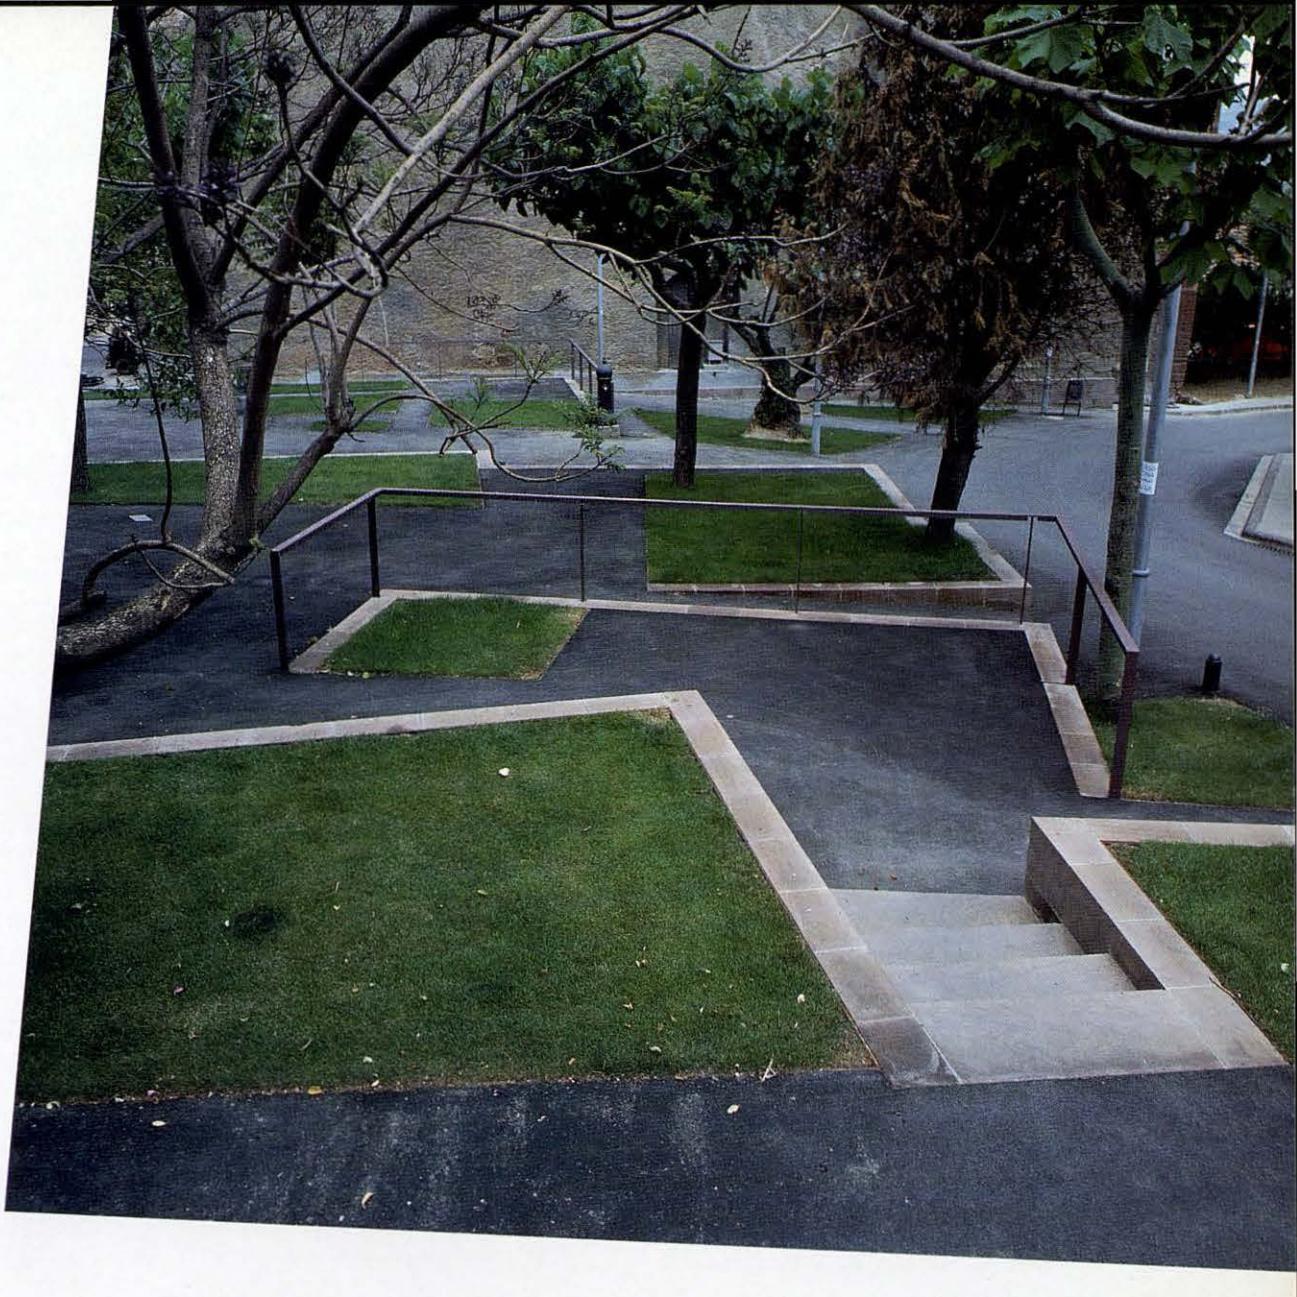
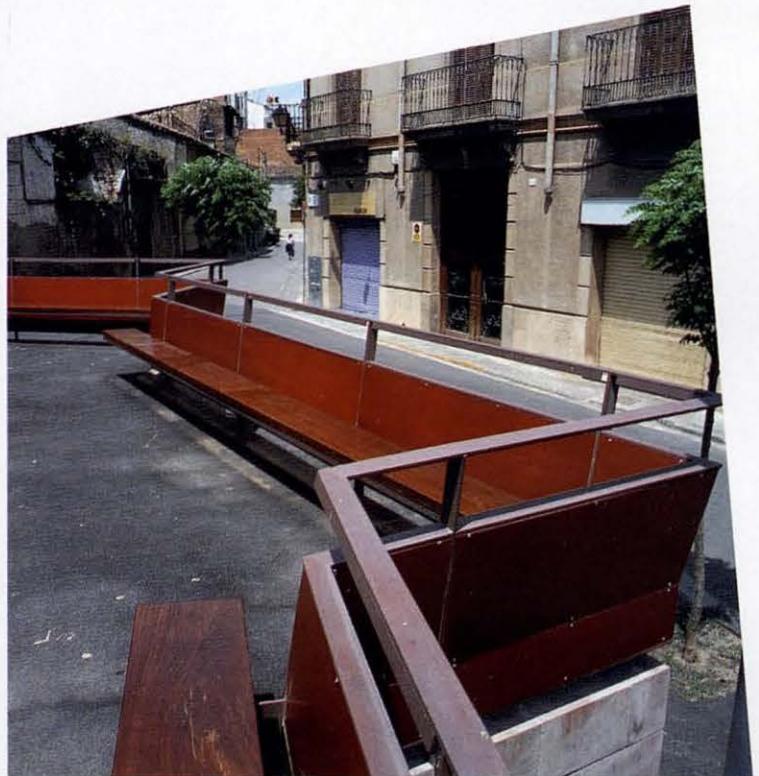
The same materials were employed here as in the first operation: asphalt for the paving and reddish stone for the walls.
